SONOMA COUNTY LIBRARY

APPENDIX 3 ARCHITECTURE FACILITIES ASSESSMENT

submitted by
MKTHINK

**Sonoma County Library
Appendix 3:
Architecture Facilities
Assessment**

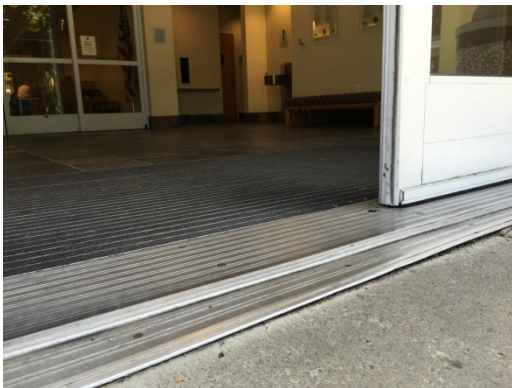
(Photo 51) Damaged threshold

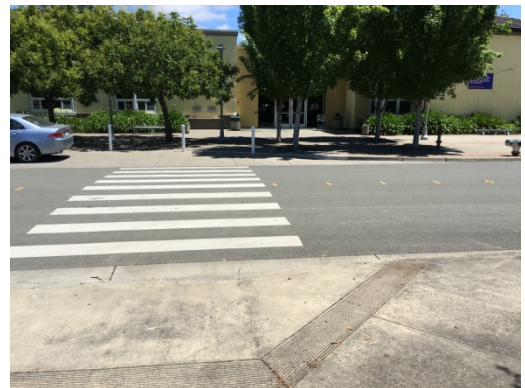
Parking – Seven (7) accessible parking spaces are available to the public and staff on-site with compliant curb cut access to the main entrance of the building. Striping is blue. Striping is in good condition. All accessible parking is located either across the driveway/ access aisle from the main entrance to the building. An accessible drop-off area is provided directly in front of the building; however, it is not marked as a parking area. The general public was seen using this area to park and enter the library.

(Photo 52) Distant accessible parking spaces

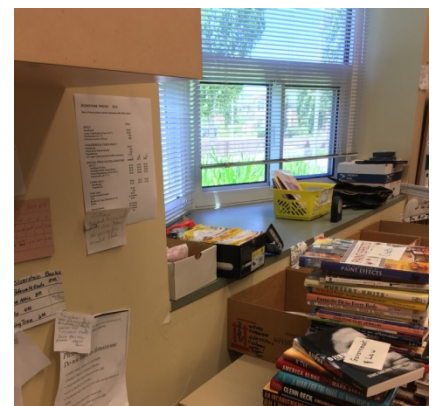
The Rohnert Park-Cotati branch is a stucco-clad structure with areas of flat roofing and sloped shingles. Windows are an aluminum storefront system and aluminum frames in punched openings. The building has skylights along the main reading room ridgeline, and the structure appeared in good condition. A recent roof leak from the flat top of a bay window was said to have been addressed by maintenance staff, but interior evidence of the former leak is still visible.

(Photo 55) Water damage to wall

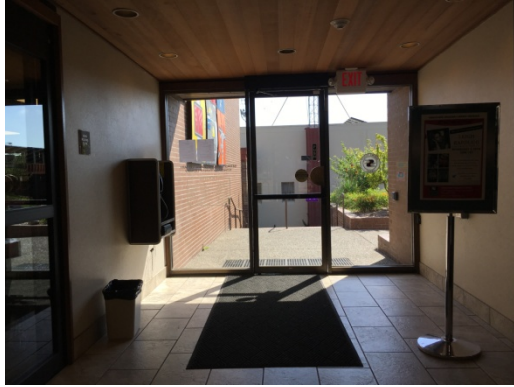
(Photo 59) Non-compliant toe kick @ egress door

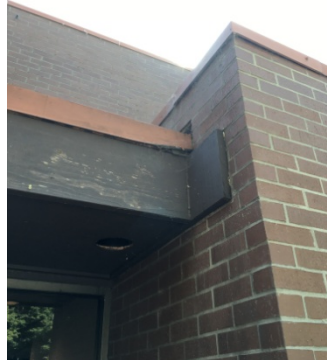
(Photo 60) Weathering & water damage

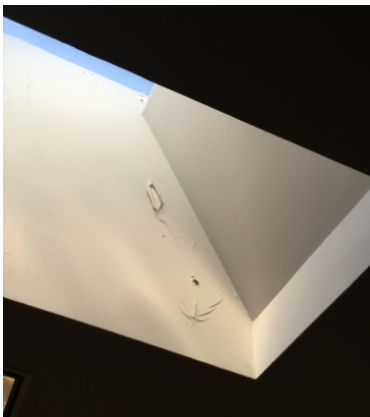
(Photo 69) Ceiling water damage

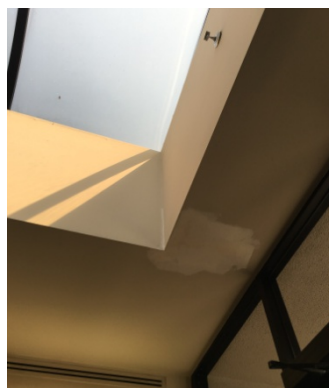
(Photo 70) Ceiling water damage

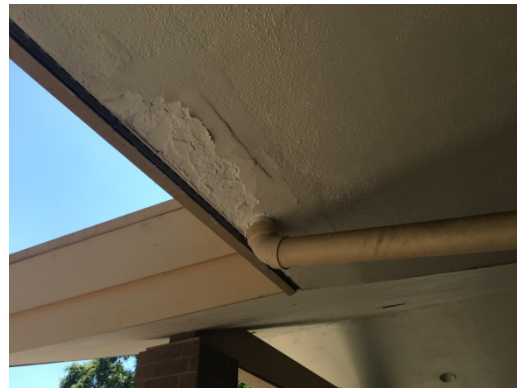
The Cloverdale branch is a brick-veneer structure with areas of painted horizontal siding and comp shingle roofing. The windows are aluminum storefront system and aluminum windows in punched openings. Water damage to the underside of the eaves was noticeable, and in one area a clog was causing active leaking through the gutter and fascia board. Numerous soffit areas have been water-damaged from debris build-up and gutter blockage.

(Photo 83) Water damage to soffit

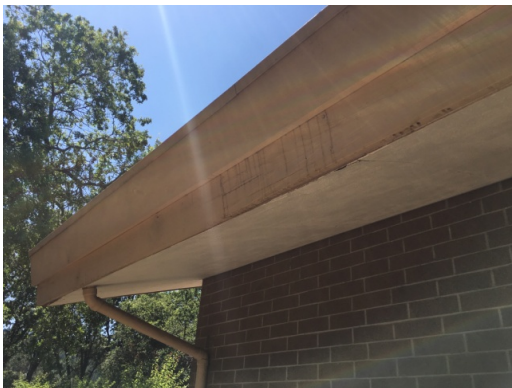
(Photo 84) Water damage to fascia boards

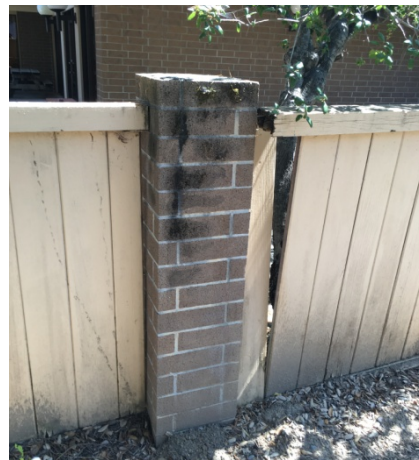
(Photo 85) Damaged perimeter fencing

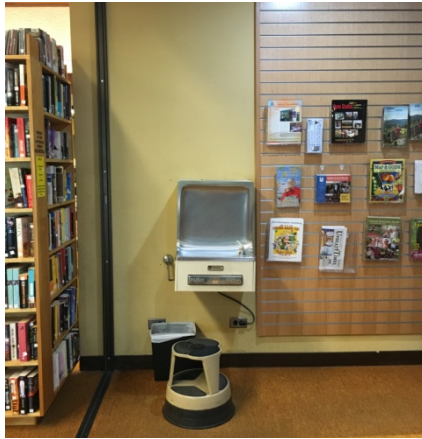
(Photo 86) Non-compliant drinking fountain

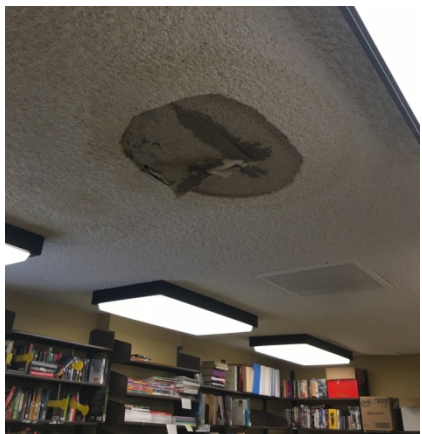
(Photo 90) Water damage to ceiling

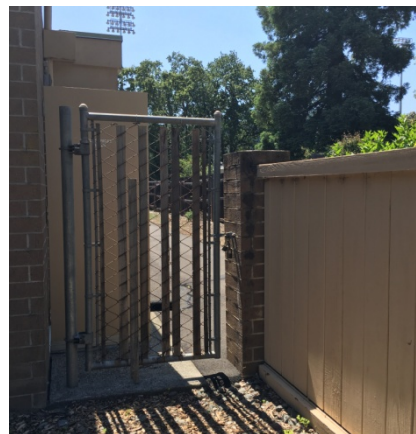
(Photo 91) Non-compliant path of travel

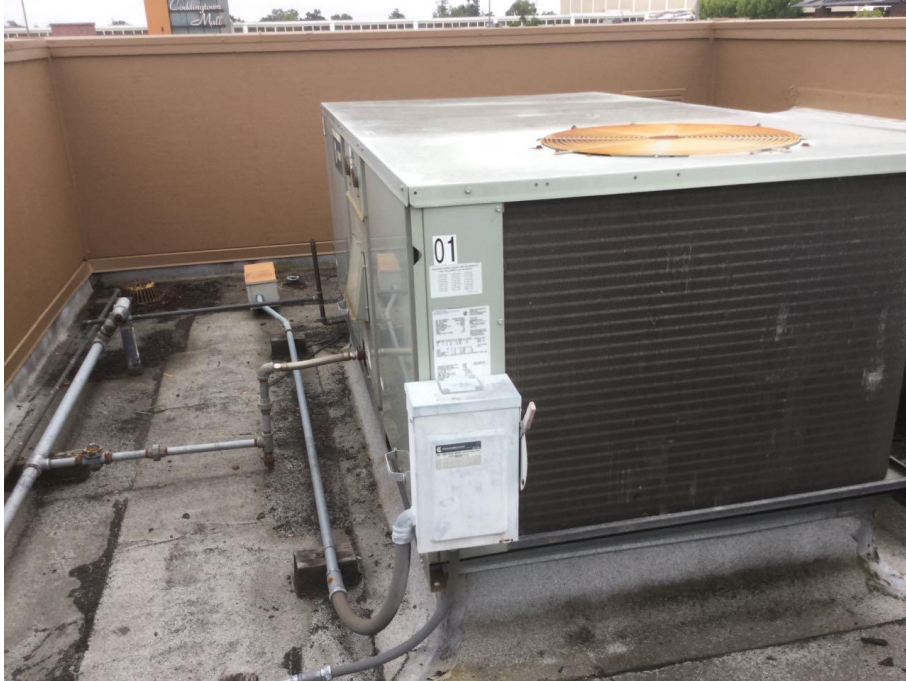
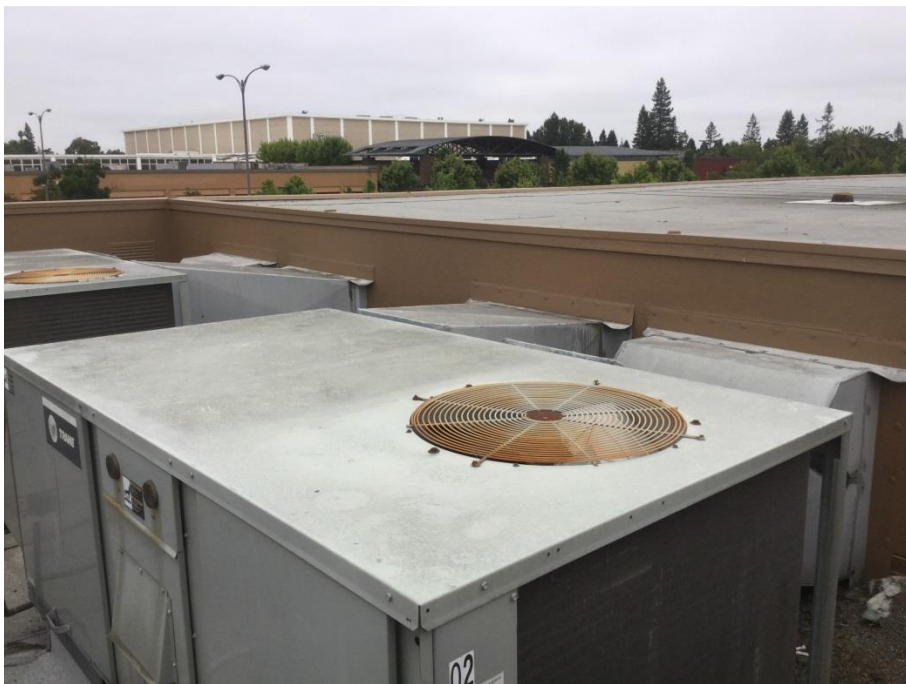
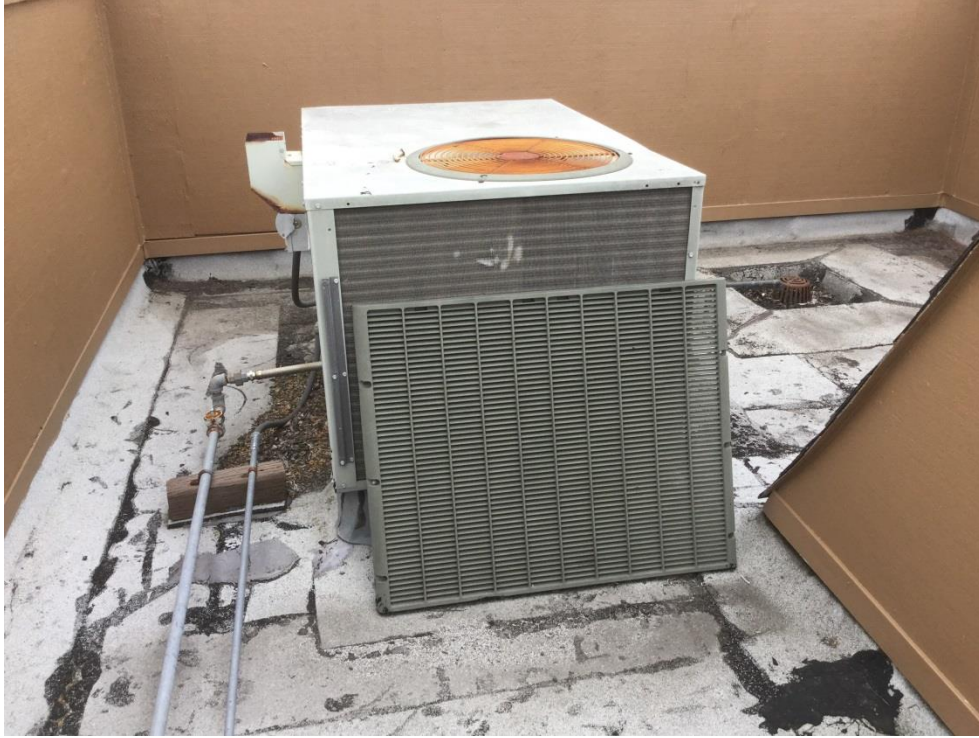
The Northwest Regional branch library in Santa Rosa was built in 1967. A mechanical renovation was completed in 1997 which replaced the original equipment in kind. The building is served by (3) single-zone packaged AC units located on the eastern roof. AC-1 and AC-2 serve the main library area while AC-3 serves the back of house areas including the staff lounge and storage. Cooling is provided via direct expansion (DX) with compressors that utilize refrigerant R-22. R-22 is currently not compliant with Title 24 and is no longer being produced. Heating is provided via a natural gas furnace. Due to the age of the units, it is unlikely that the economizers are functioning properly. The units appear to be in decent working condition and there are no reported operational issues. It was reported that there are no issues meeting the temperature set point in heating or cooling throughout the building.

All three packaged units are beyond their recommended service life and it is recommended that they be replaced in kind. The new units will be provided with local economizer controls which reduces energy usage by using outside air for free cooling when it is available. Additionally, the new units use refrigerant R410A, which complies with Title 24 requirements.

It is also recommended that a new Automated Logic Controls system be installed to integrate this building into a new central controls system.

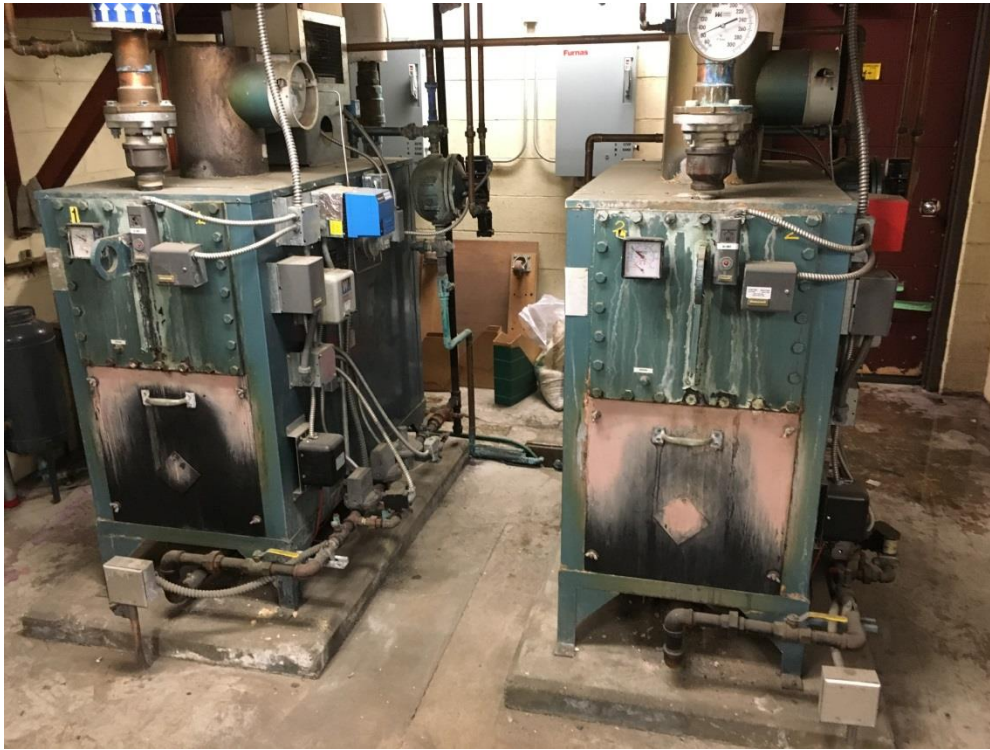
Image 4: B-1, B-2

There are two non-condensing boilers with an output capacity of 506 MBH each. The heating hot water system is piped as a primary only system with constant volume flow. The boilers appear to be in poor condition and are within 3 years of the end of their useful service life.

It is recommended that the heating hot water system be replaced with condensing boilers and a constant primary/variable secondary piping arrangement. This solution will increase the combustion efficiency of the boilers to over 90% and will allow the water temperature and flow to be reset based on building load saving significant energy. If the heating plant is replaced with condensing boilers, the heating coils throughout the building must be replaced to operate at different temperatures.
