SONOMA COUNTY LIBRARY

APPENDIX 3 ARCHITECTURE FACILITIES ASSESSMENT

submitted by
MKTHINK

**Sonoma County Library
Appendix 3:
Architecture Facilities
Assessment**

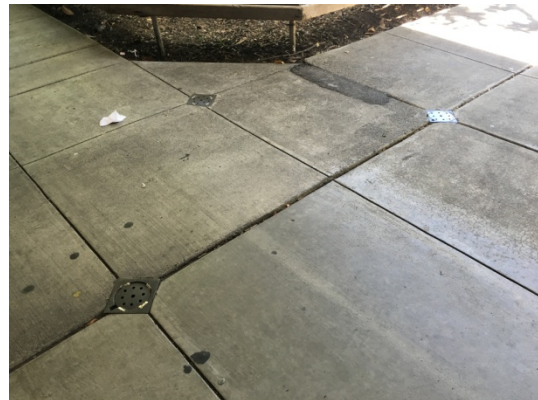
(Photo 03) Concrete pavement separation

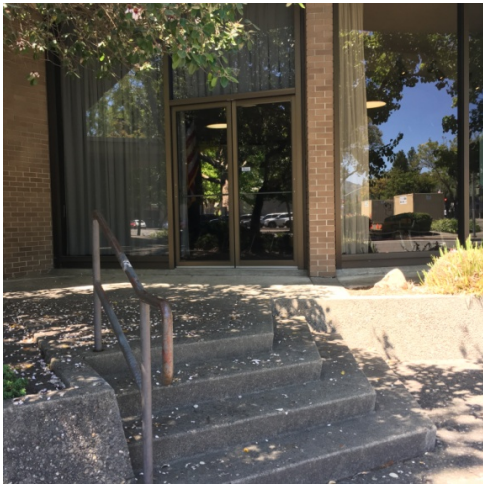
(Photo 06) Non-compliant Egress Stair

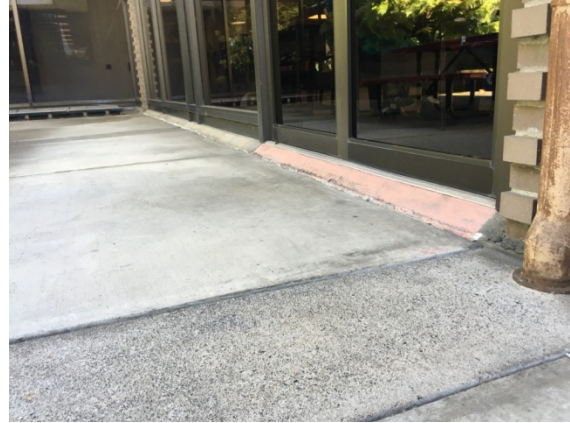
(Photo 07) Non-compliant Door Threshold

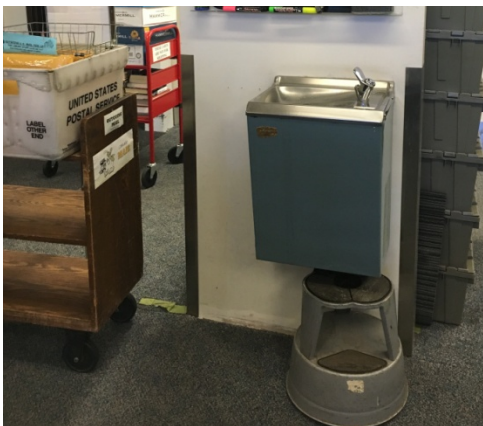
(Photo 08) Non-compliant Drinking Fountain

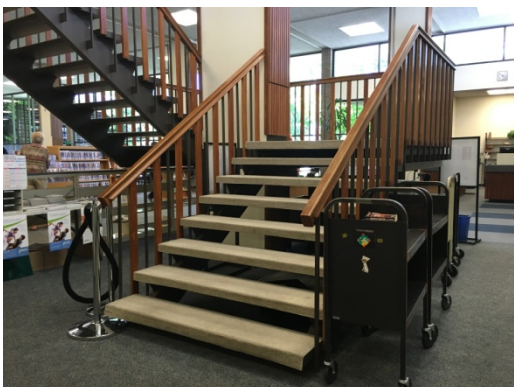
(Photo 10) Non-compliant handrail extensions & visual contrasting warnings

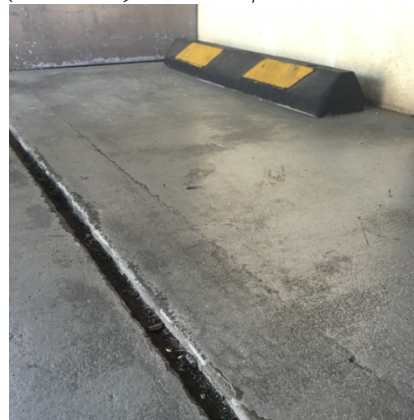
(Photo 11) Concrete gap @ Staff Entrance

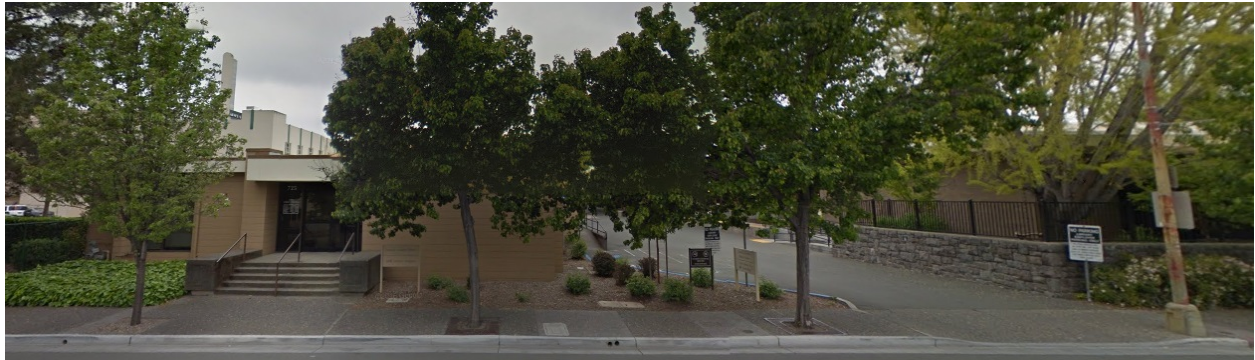
(Photo 12) Main Entrance - 725 3rd Street: Non-compliant ramp adjacent Staff Parking area/Loading Zone
Image Courtesy of Google

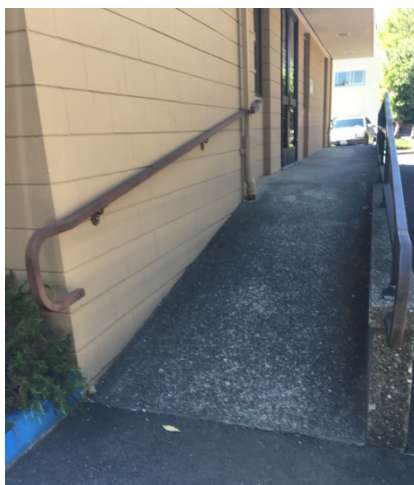
(Photo 15) Non-compliant ramp to Annex

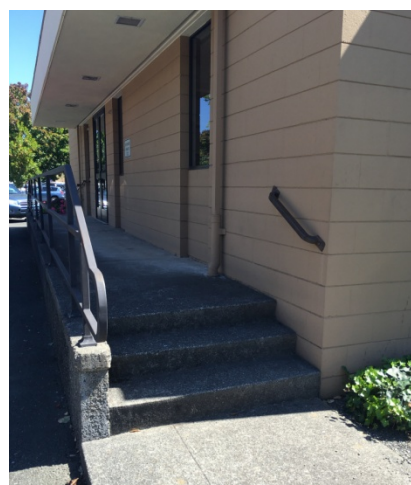
(Photo 16) Non-compliant stair to Annex

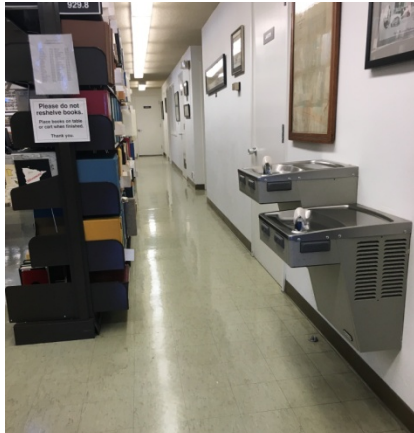
(Photo 17) Non-compliant high-low drinking fountain

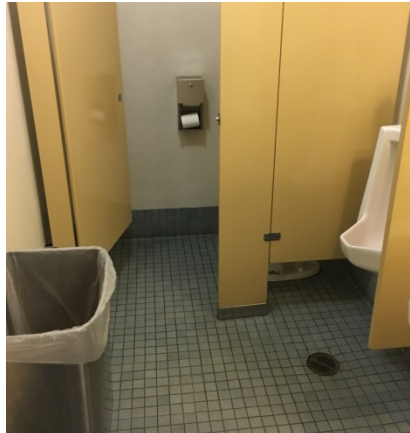
(Photo 18) Non-compliant men's restroom

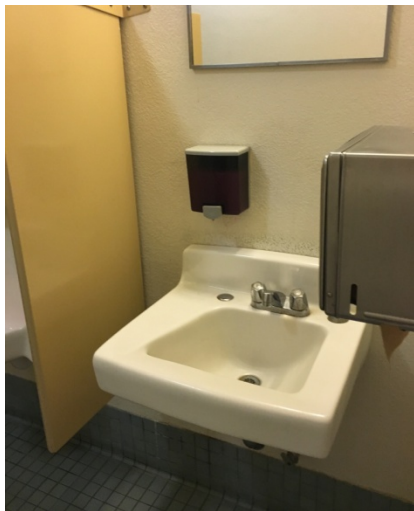
(Photo 19) Non-compliant vanity

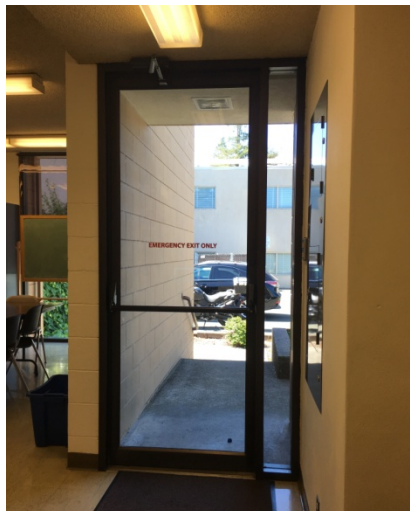
(Photo 20) Egress door w/o illuminated exit signage

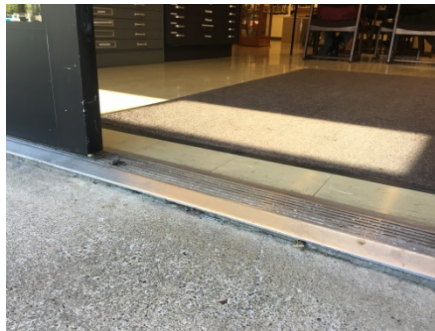
(Photo 22) Threshold requiring maintenance

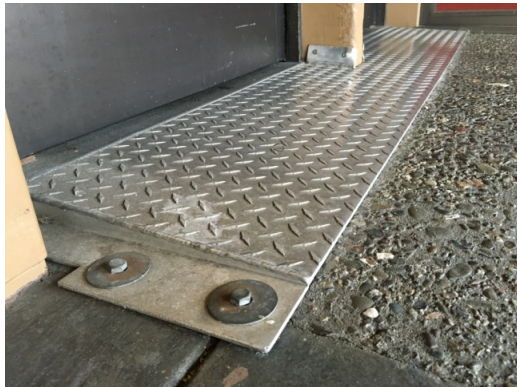
(Photo 24) Modified threshold

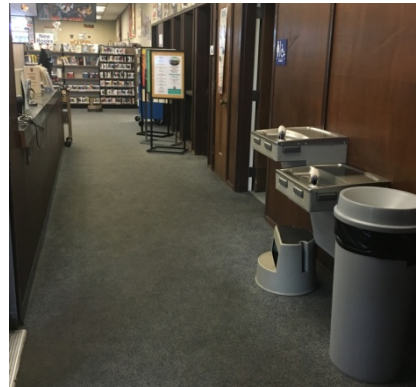
(Photo 25) Non-compliant pocketing along circ.

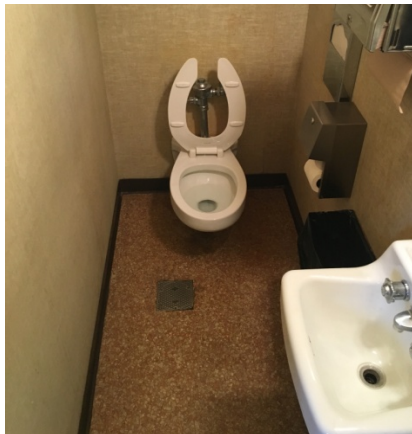
(Photo 26) Non-comp. restroom

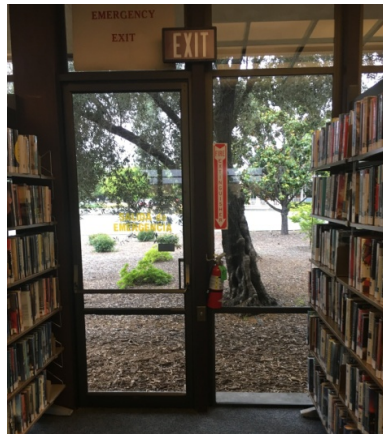
(Photo 27) Non-compliant exit

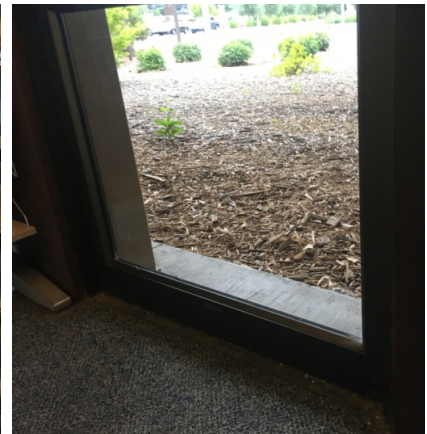
(Photo 28) Non-compliant exit

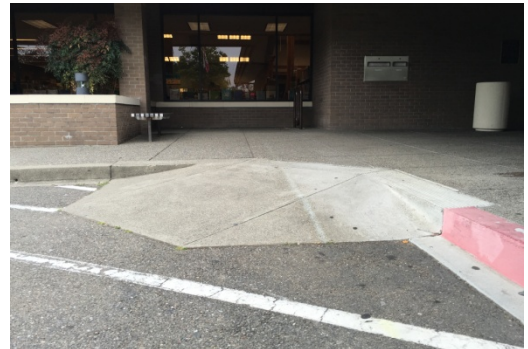
(Photo 31) Non-compliant path of travel

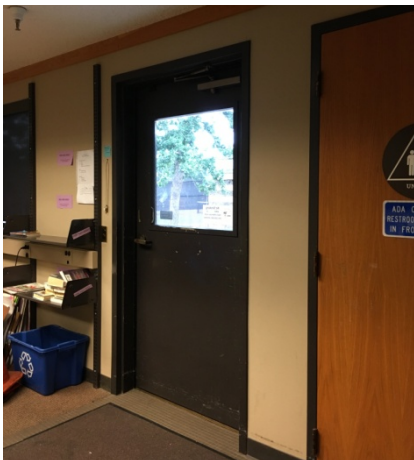
(Photo 32) Non-compliant egress door

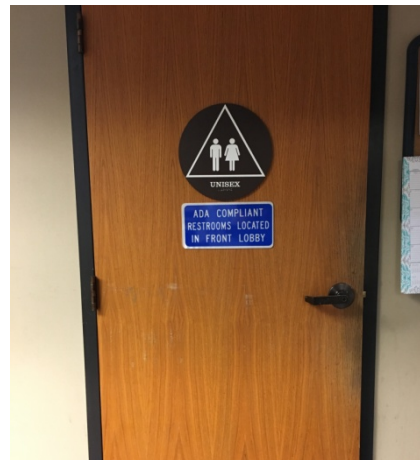
(Photo 33) Non-compliant staff restroom

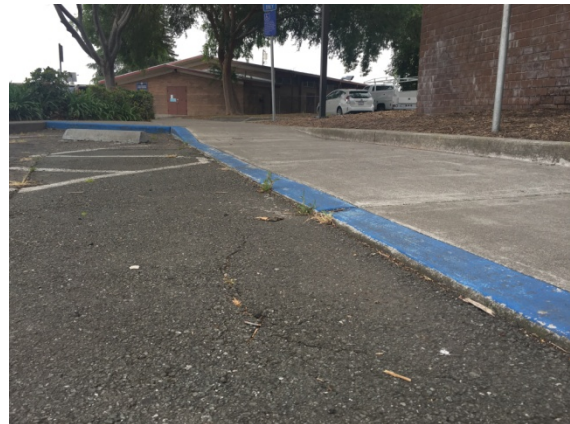
(Photo 41) Non-compliant accessible path

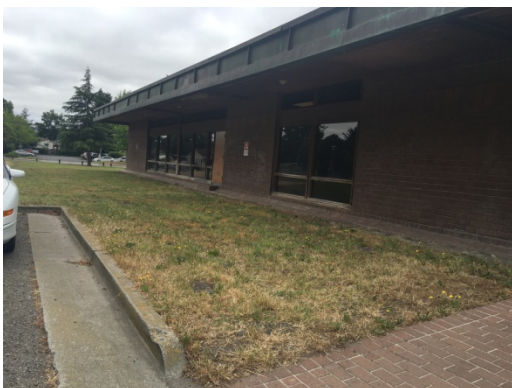
(Photo 42) Non-compliant ramp & threshold

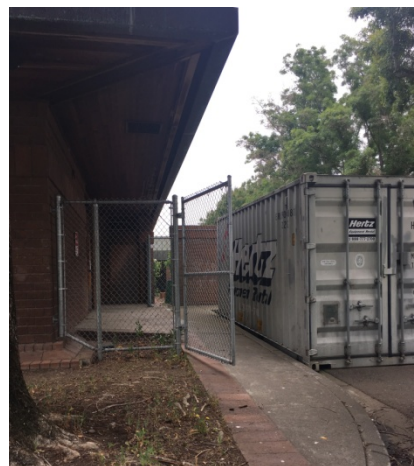
(Photo 43) Gated, chain-link construction fence

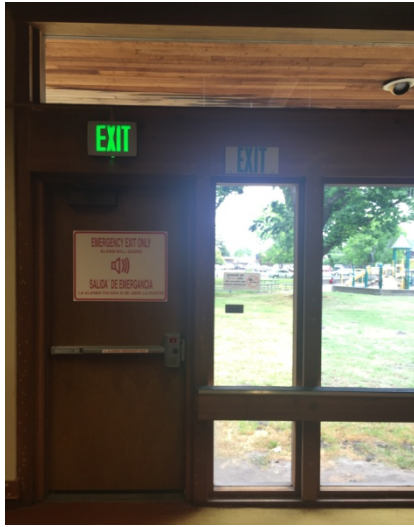
(Photo 44) Non-compliant path of egress

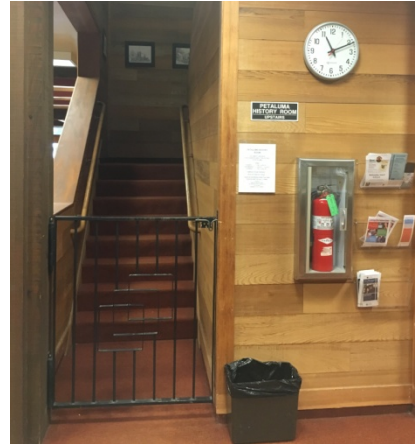
(Photo 45) Non-compliant public stair

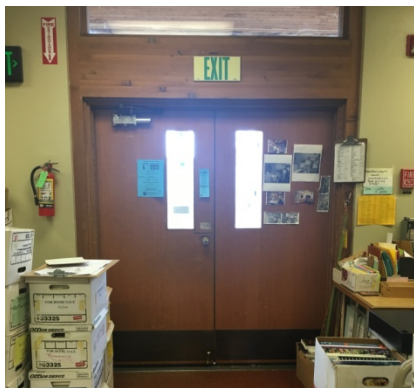
(Photo 46) Non-compliant egress door

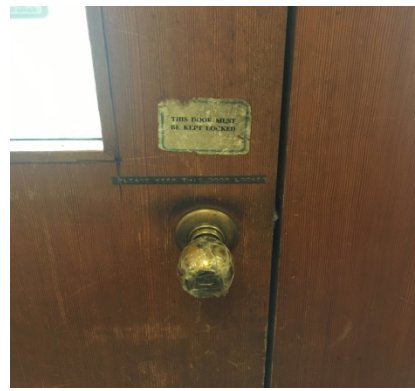
(Photo 47) Non-compliant door hardware

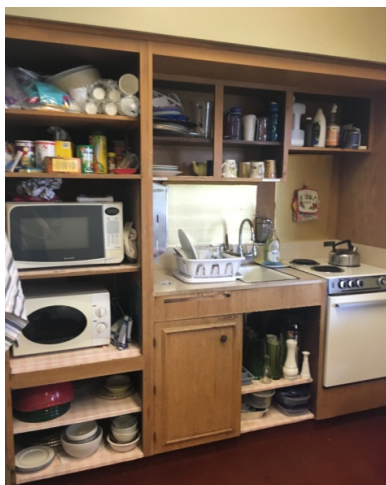
(Photo 48) Non-compliant staff break area

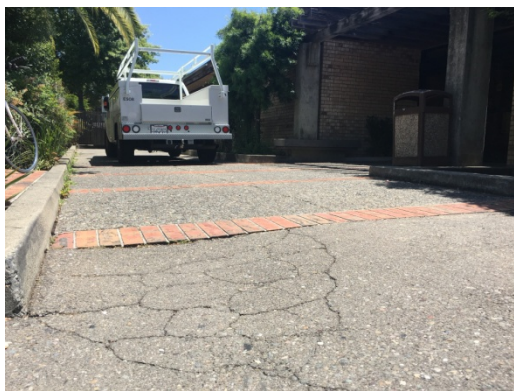
(Photo 62) Non-compliant path of travel

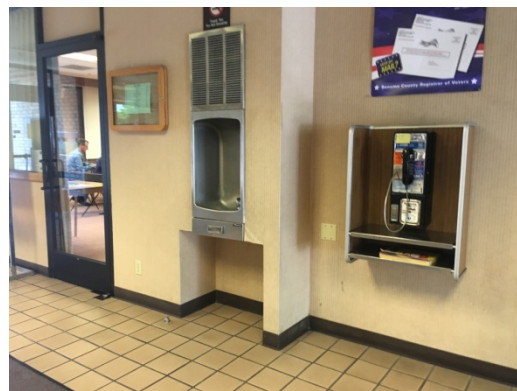
(Photo 63) Non-compliant drinking fountain

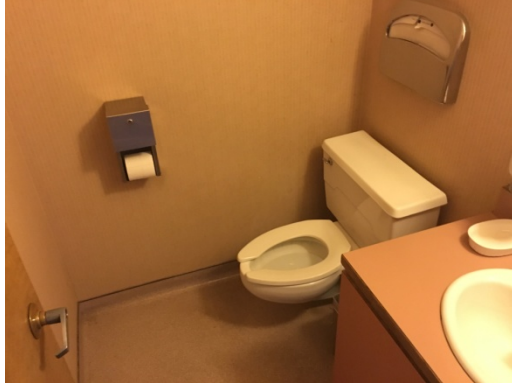
(Photo 64) Non-compliant staff restroom

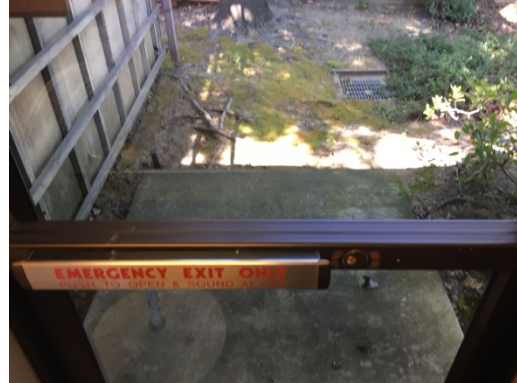
(Photo 65) Non-compliant path of travel

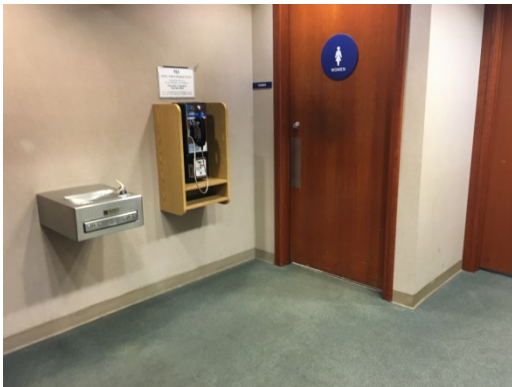
(Photo 67) Non-compliant drinking fountain

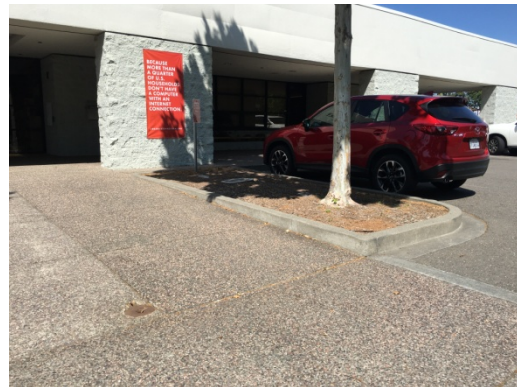
(Photo 68) Non-compliant path of travel

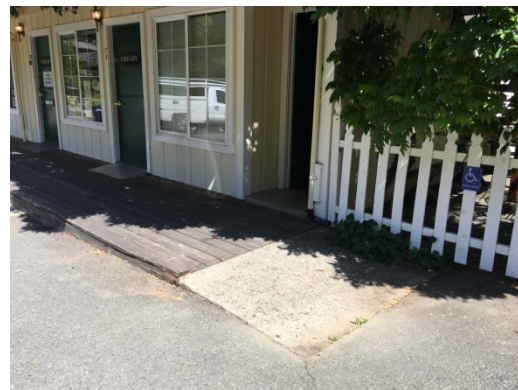
(Photo 73) Non-compliant path of travel

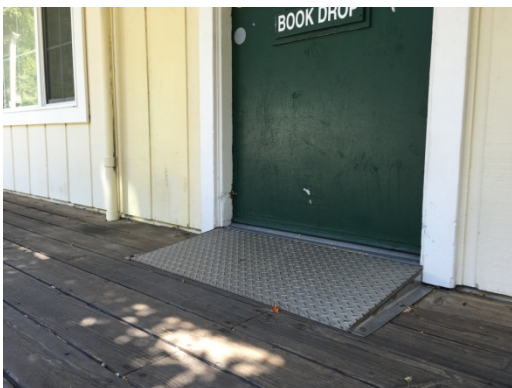
(Photo 74) Non-compliant threshold

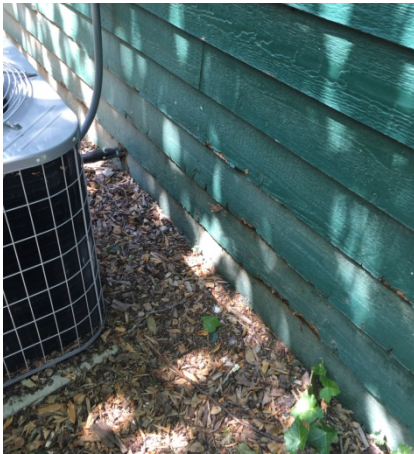
(Photo 77) Peeling paint @ base of wall

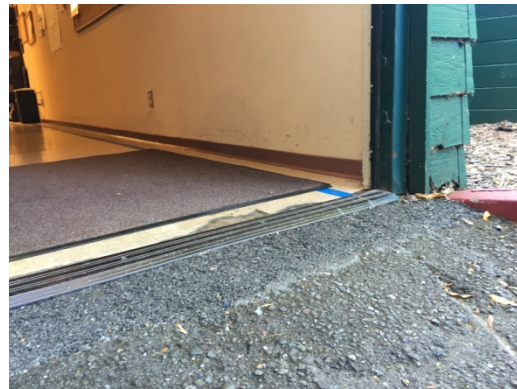
(Photo 78) Non-compliant path of travel

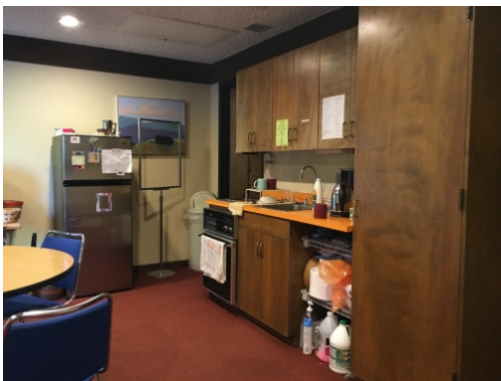
(Photo 79) Non-compliant staff break area

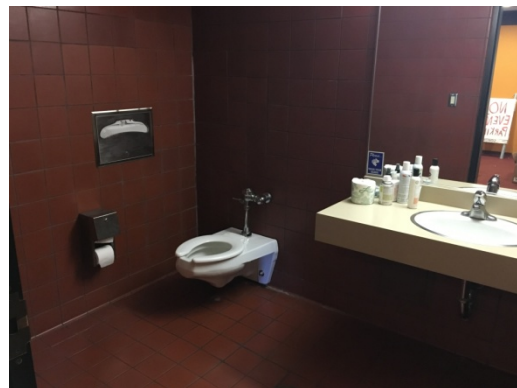
(Photo 80) Non-compliant staff restroom

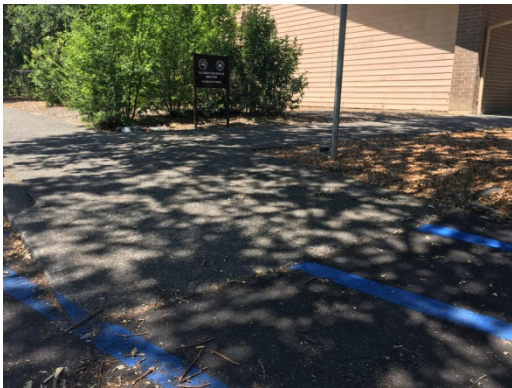
(Photo 82) Non-compliant path of travel

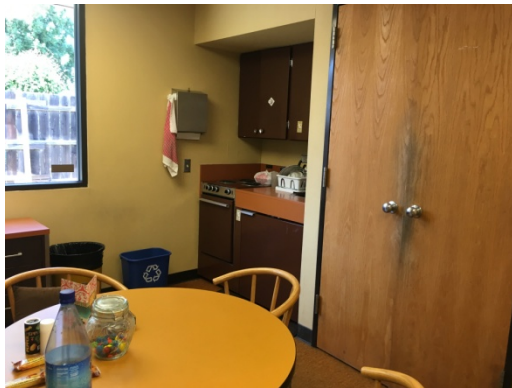
(Photo 88) Non-compliant staff break area

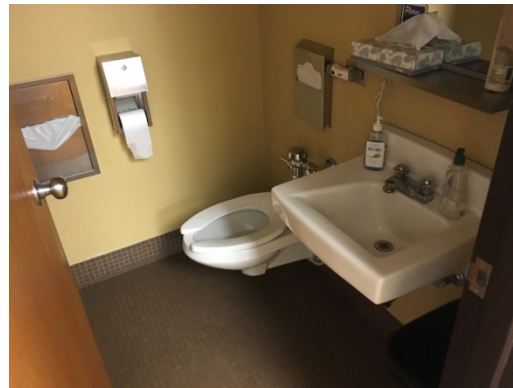
(Photo 89) Non-compliant staff restroom
