SONOMA COUNTY LIBRARY

APPENDIX 3 ARCHITECTURE FACILITIES ASSESSMENT

submitted by
MKTHINK

**Sonoma County Library
Appendix 3:
Architecture Facilities
Assessment**

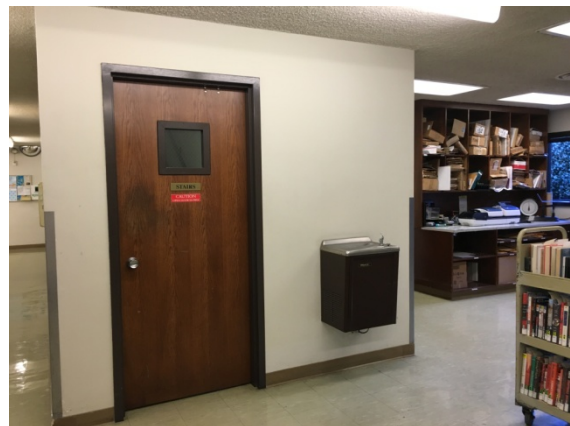
(Photo 09) Non-compliant Door Knob & DF

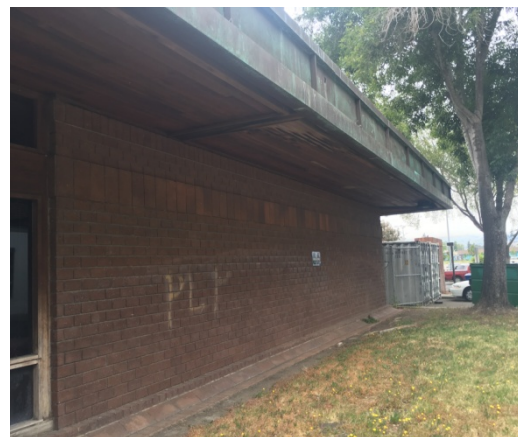
(Photo 49) Graffiti on building

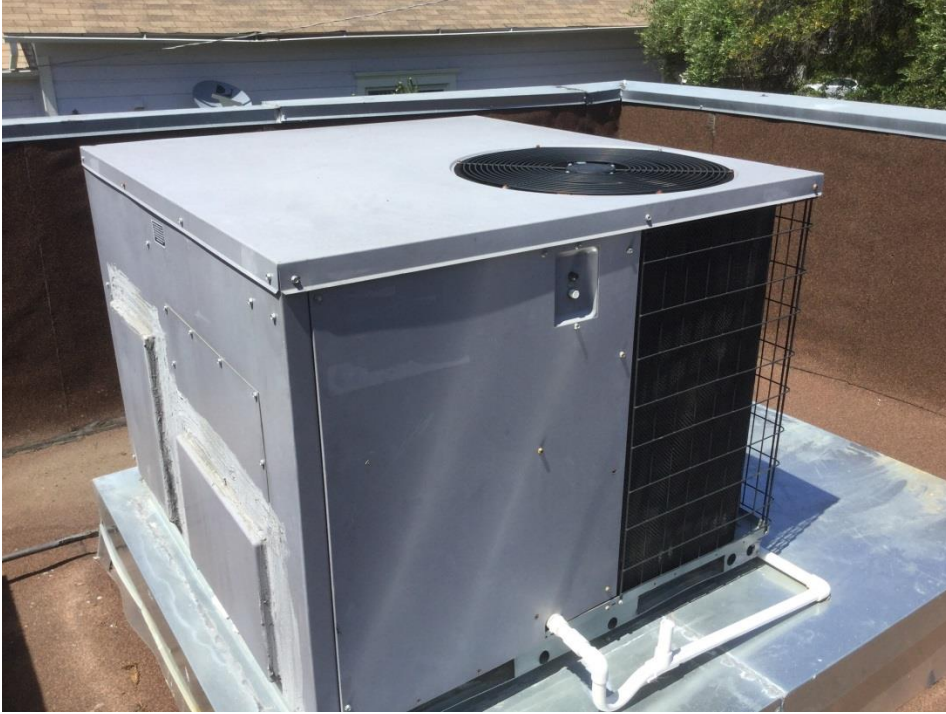
Image 39: AC-4

The Cloverdale Regional in Cloverdale was built in 1977. A mechanical renovation occurred in 2003 which replaced some of the existing mechanical equipment. The building is served by (4) single-zone packaged AC units and a furnace. AC-1 through AC-4 and the furnace are located on the roof and serves the library. Cooling is provided via direct expansion (DX) with compressors that utilize refrigerant R-22. R-22 is currently not compliant with Title 24 and is no longer being produced. Due to the age of the equipment, it is unlikely that the economizer is functioning properly. The units appear to be in mediocre working condition. The units are approximately 13-20+ years old and are either at or very near the end of their useful service life. The main library is able to meet set-point.

All equipment has reached the end of the recommended service life, and is recommended to be replaced in kind. The new units will be provided with local economizer controls which reduces energy usage by using outside air for free cooling when it is available. Additionally, the new units use refrigerant R410A, which complies with Title 24 requirements.

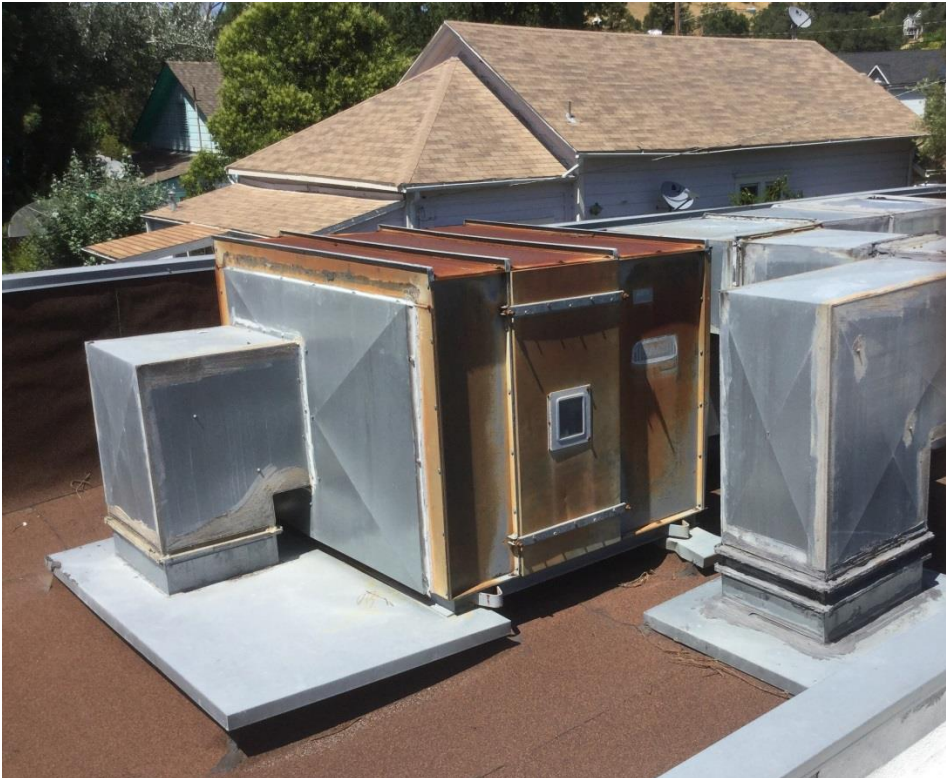
Image 40: ROOFTOP EQUIPMENT

There have been several leaks through the roof that caused damage to the ceiling below. Currently, there is one ongoing leak. The leak comes from AC-1 (located in the middle of the equipment on the roof). Water is deposited into the ductwork after the coil where it builds up and then drops into the ceiling space where it escapes the ductwork. Standing water within ductwork represents a significant threat of Legionnaires disease. The disease breeds in the standing water and becomes airborne due to the airflow over the water. The disease is then delivered to the library where it can be breathed in by the occupants. People at the most risk of being seriously infected are the very young and the elderly. This demographic is the most common in a library so the public health risk is elevated. It is likely that the cause for this issue is an improperly installed p-trap on the condensate line. Due to the

lack of available height, the p-trap cannot for an airtight seal and operate as intended. This causes air to flow through the p-trap back into the unit and prevents water from flowing down the condensate line. As there is nowhere else for the condensate to go, it flows into the ductwork.

Due to the public safety hazards represented by the standing water, it is a high priority to test the airstream for any legionnaires disease. To fix the issue with the standing water, the p-trap on the condensate line needs to be redone to comply with code. This will prevent the water from building up in the unit and then discharging into the ductwork.
